**Report on the Explosion, Fire, and
Oil Spill Resulting in One Fatality
and Injury on September 21, 1978,
at Well 6 of Cavern 6 at the West Hackberry,
Louisiana, Oil Storage Site of the Strategic
Petroleum Reserve**

November 1978

U.S. Department of Energy
Washington, D.C. 20545

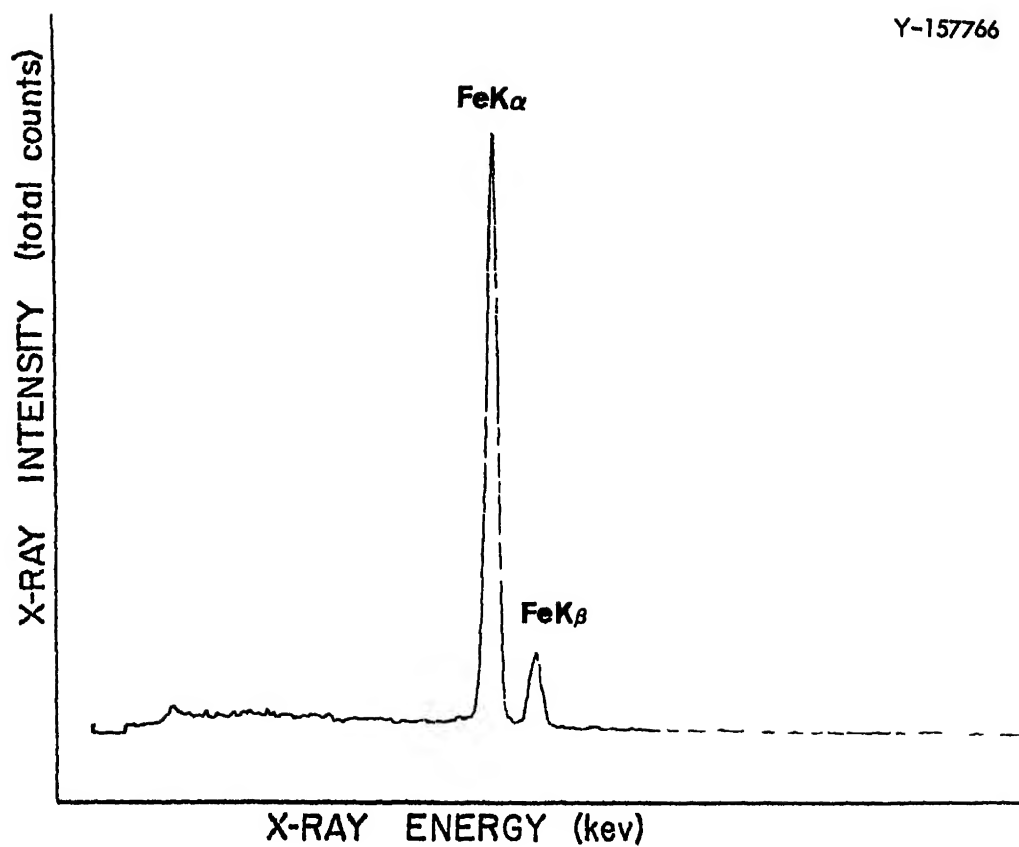
Fig. 30. Pipe 3 Scale on Inside of Pipe (Area C, See Fig. 27).

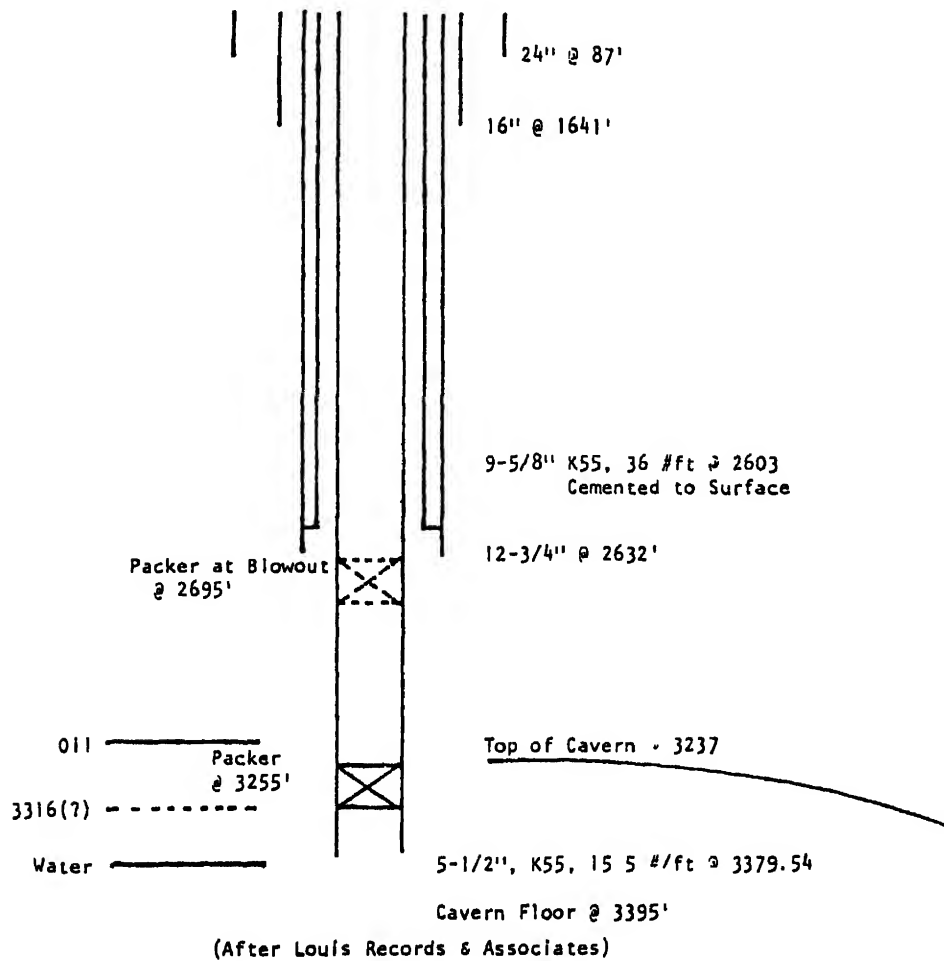
Figure 2. Casing Configuration on Well 6.

The configuration of the casing is shown in Figure 2. The drawing was taken from a sketch drawing labeled "Gulf Interstate Engineering Company" and dated 2/9/78. The casing weight and grades were taken from other Gulf Interstate Engineering Company records. The depths and sizes from Figure 2 will be used in this report.

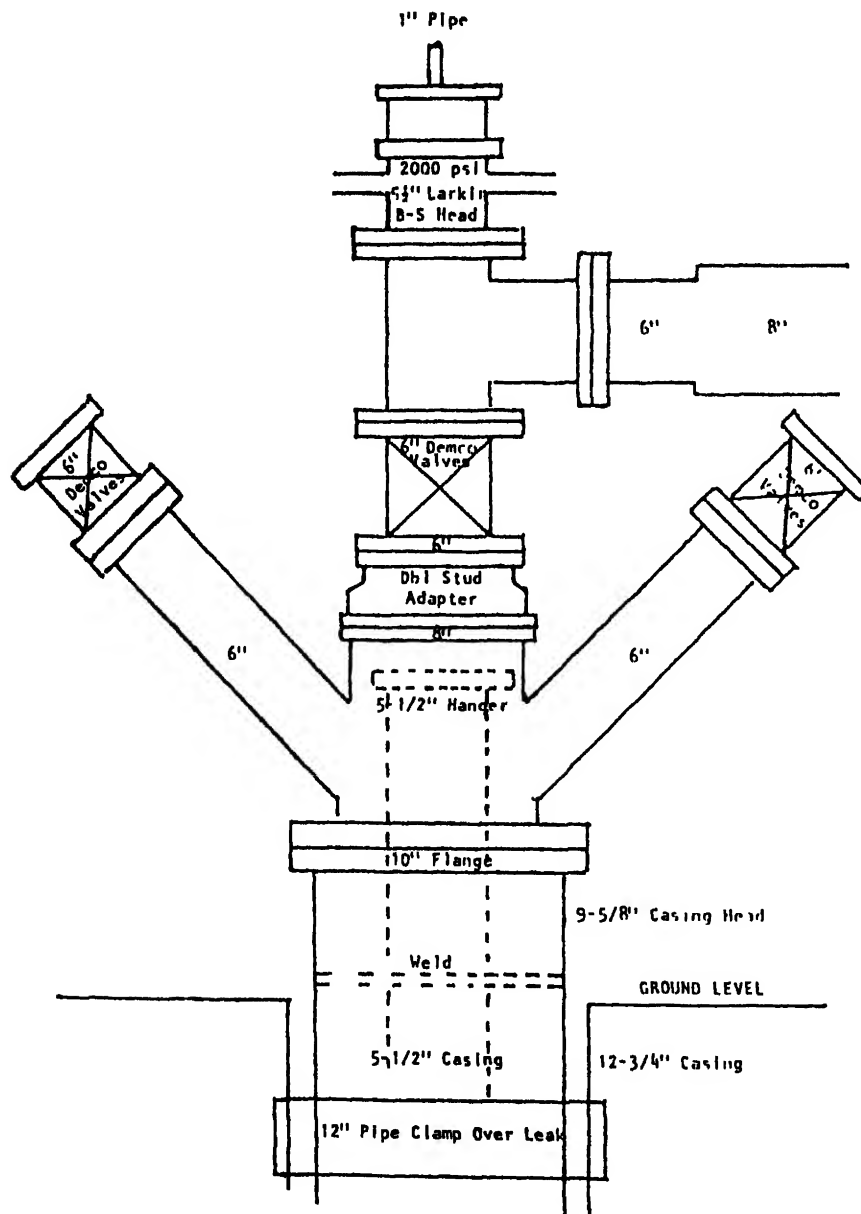
Figure 3. WEST HACKBERRY - CAVERN WELL NO. 6
BEFORE WORKOVER STARTED
(after Louis Records & Assoc.)

The configuration of the wellhead before the workover started is shown in Figure 3. The original sketch is with documents provided by Gulf Interstate Engineering Company and Louis Records and Associates. Figure 4 is a photograph of Well #11 that is supposed to be similar in all respects to the wellhead that was on Well #6. The photograph was taken September 29, 1978, at my direction by photographers assigned to the investigative committee.

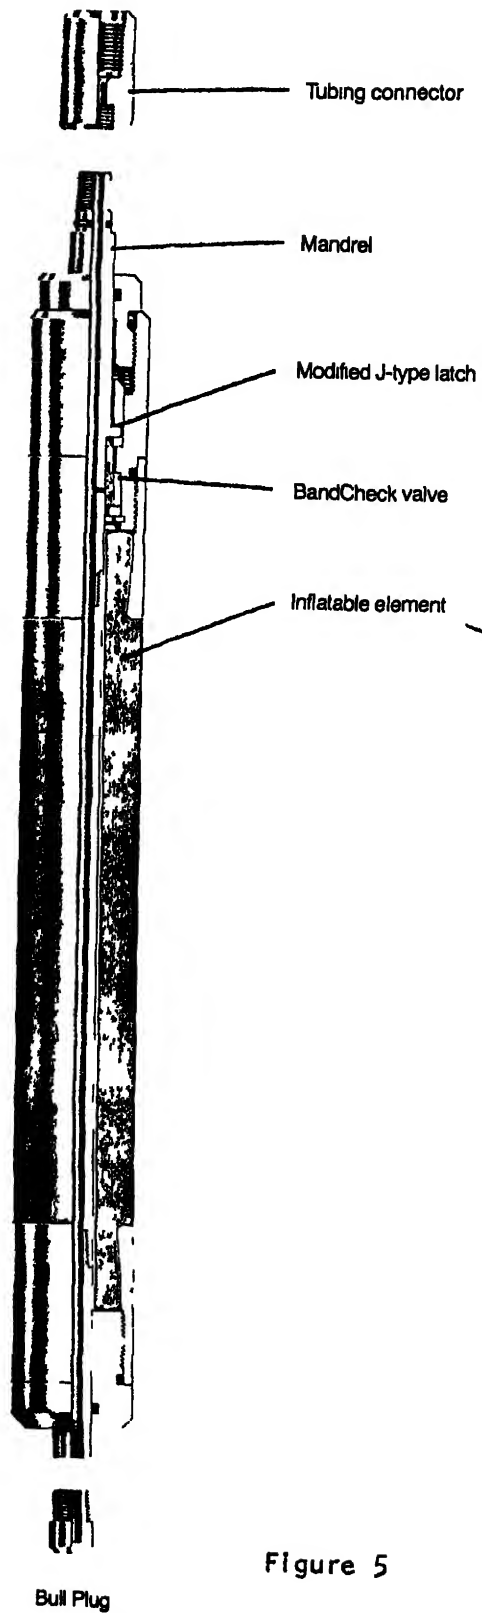
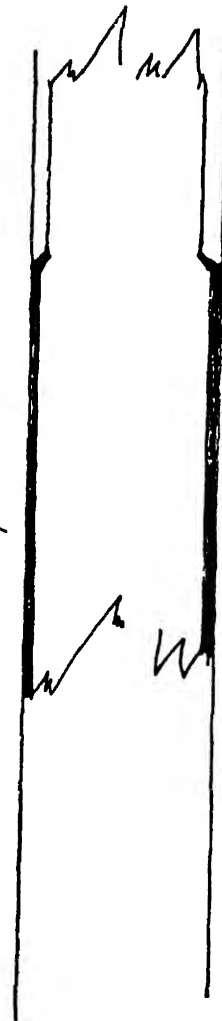
The TAM packer is shown in Figure 5 and as it was in the hole in Figure 5-A.

The TAM inflatable packer is held in the hole by the frictional force of the rubber set against the tubing or hole. The TAM International Working Pressure Chart as shown in Figure 6 indicates that the 4-1/4" packer used should have withstood a differential pressure of approximately 5000 psi. It appears the

4-1/4" Packer Inflated
in the 5-1/2" Tubing
(5-1/2" Tubing has 5" I.D.)

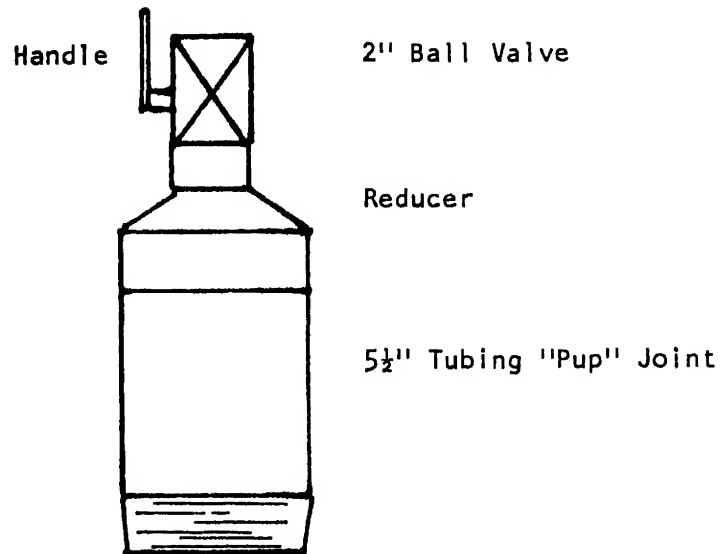
Figure 7. Safety Valve for use as stabbing valve as made up for Well 6.

The safety valve used as a stabbing valve on the Pelican rig was assembled by the drilling foreman, Mr. Irby Hogue, from a short "pup" joint of 5-12/" tubing and a 2" ball valve from the wellhead (Figure 7). The BJ cementer testified he brought up a 5-1/2" x 2" cementing head when the well started to flow. The cementing head would be essentially similar to the drawing in Figure 7.

As a stabbing safety valve, the valve as made up has two difficiencies:

1. The valve has no handles to facilitate its being quickly installed on the tubing.
2. The valve should be full opening. A restriction in the valve will build a back pressure when the valve is being stabbed that will make it difficult to install on the flowing tubing.

Items 1 and 2 were what happened according to Mr. Hogue's testimony. He and the crew could not get the valve down on tubing threads. This was because of the restriction in the valve and the lack of handles. However, it needs to be noted here that a 5-1/2" safety valve is not a standard (off the shelf) piece of equipment.

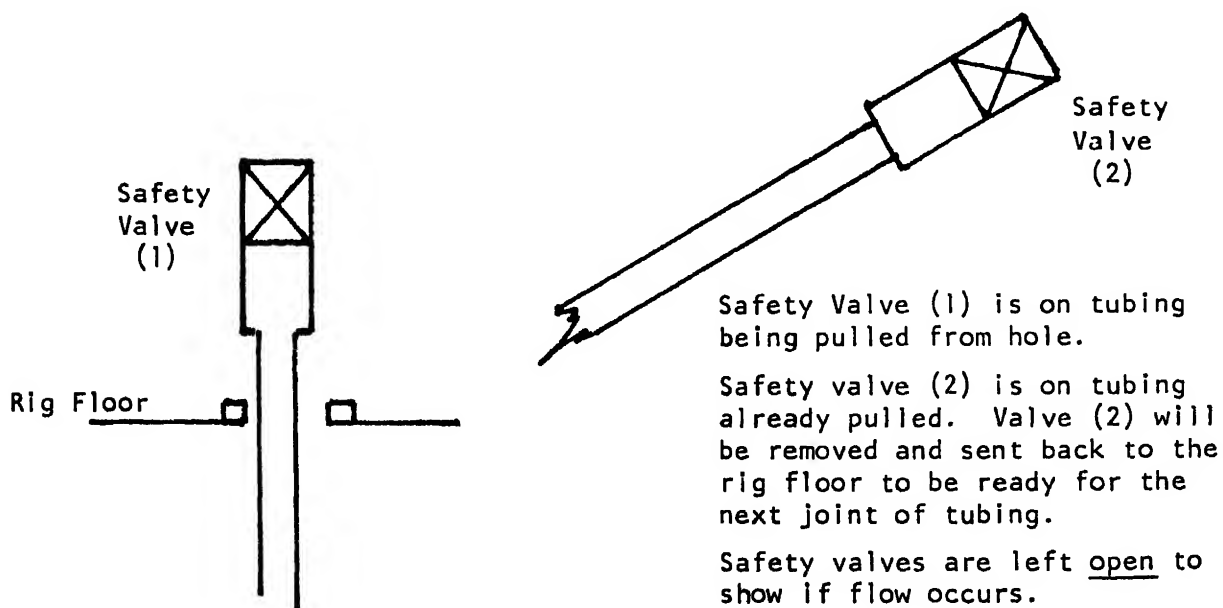
Figure 9. Use of Double Safety Valves
When Pulling Tubing.

The safety valves for pulling or running pipe fit the casing joint. When the pipe is pulled out of the hole, one safety valve is installed on the top joint of pipe in the hole, at all times (see Figure 9). As soon as the top joint of pipe is unscrewed, a safety valve is screwed onto the joint of pipe remaining in the hole. The valve that was on the top of the joint pulled from the hole is removed and returned for the next joint of pipe. The sequence of installing the safety valves is reversed when running the pipe. The safety valve is kept open so that any flow of mud or fluid from the well can be seen.

Note: The sequence of installing the safety valves is reversed when running the pipe.

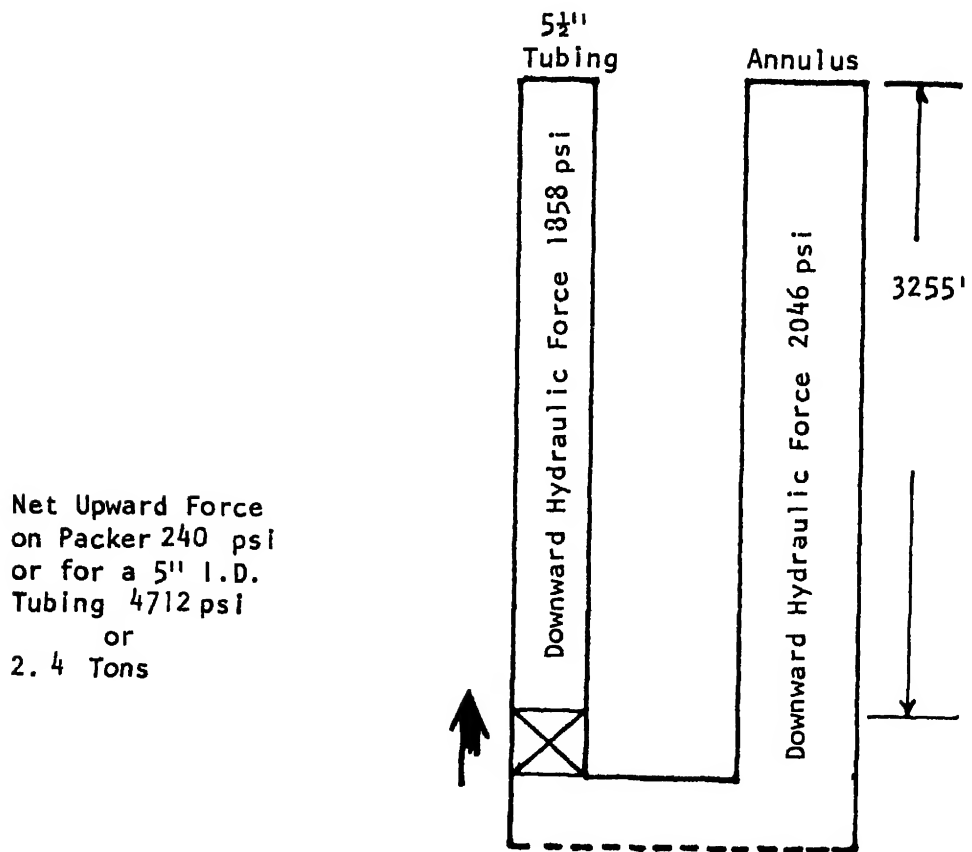
Figure 10.

The pressure opposite the packer would then be 2,046 psi (Figure 10)

Initial downward hydraulic force on the TAM packer was 1,876psi (figure 10).

Well 6 As A "U" Tube INITIAL HYDRAULIC FORCES ON THE PACKER

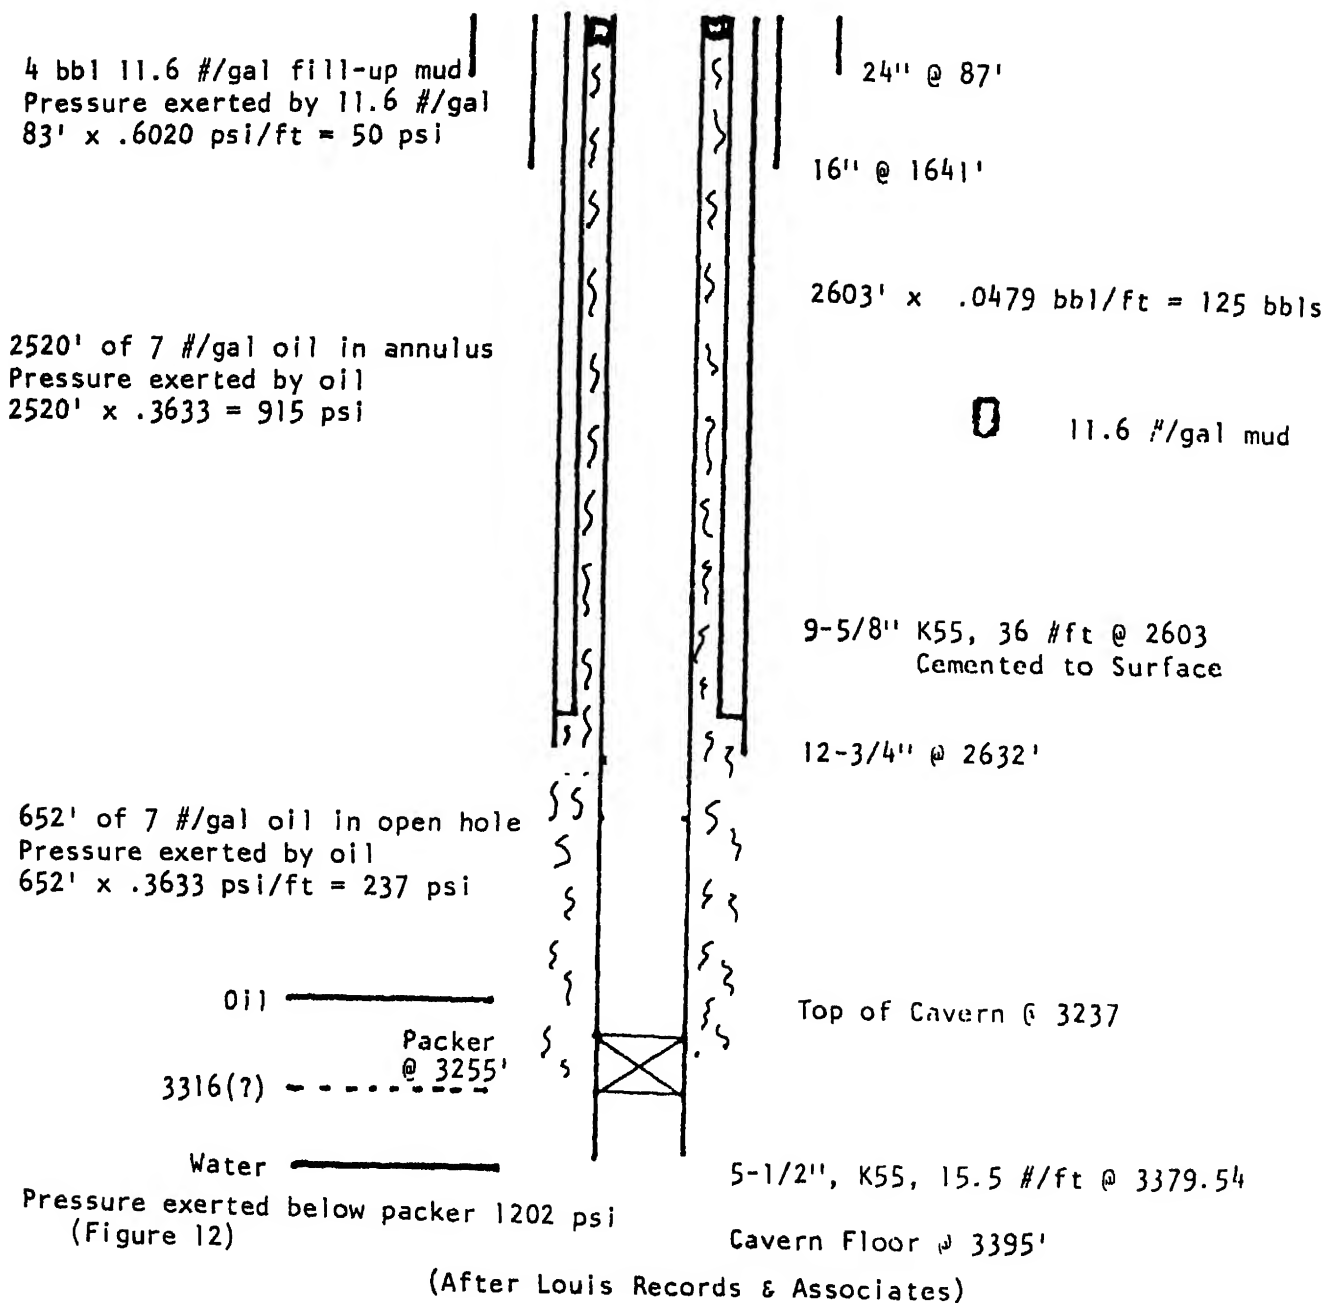
Before pulling the 5-1/2" tubing, the hydraulic pressure in the annulus opposite to the packer would have been 1295 psi (Figure 12) (Figure 2-C).

11.6 #/gal mud 83' x .6020 psi/ft	=	50 psi
7 #/gal (oil) (2603 - 83') x .3633 psi/ft	=	915 psi
7 #/gal (oil) (3255 - 2603) x .3633 psi/ft	=	<u>237</u> psi
Pressure below packer =		1202 psi

Figure 2-C
 Cavern Pressure Reduced to 50 psi Potential
 Condition on Well 6 with Well Dead Before
 Pulling Casing.

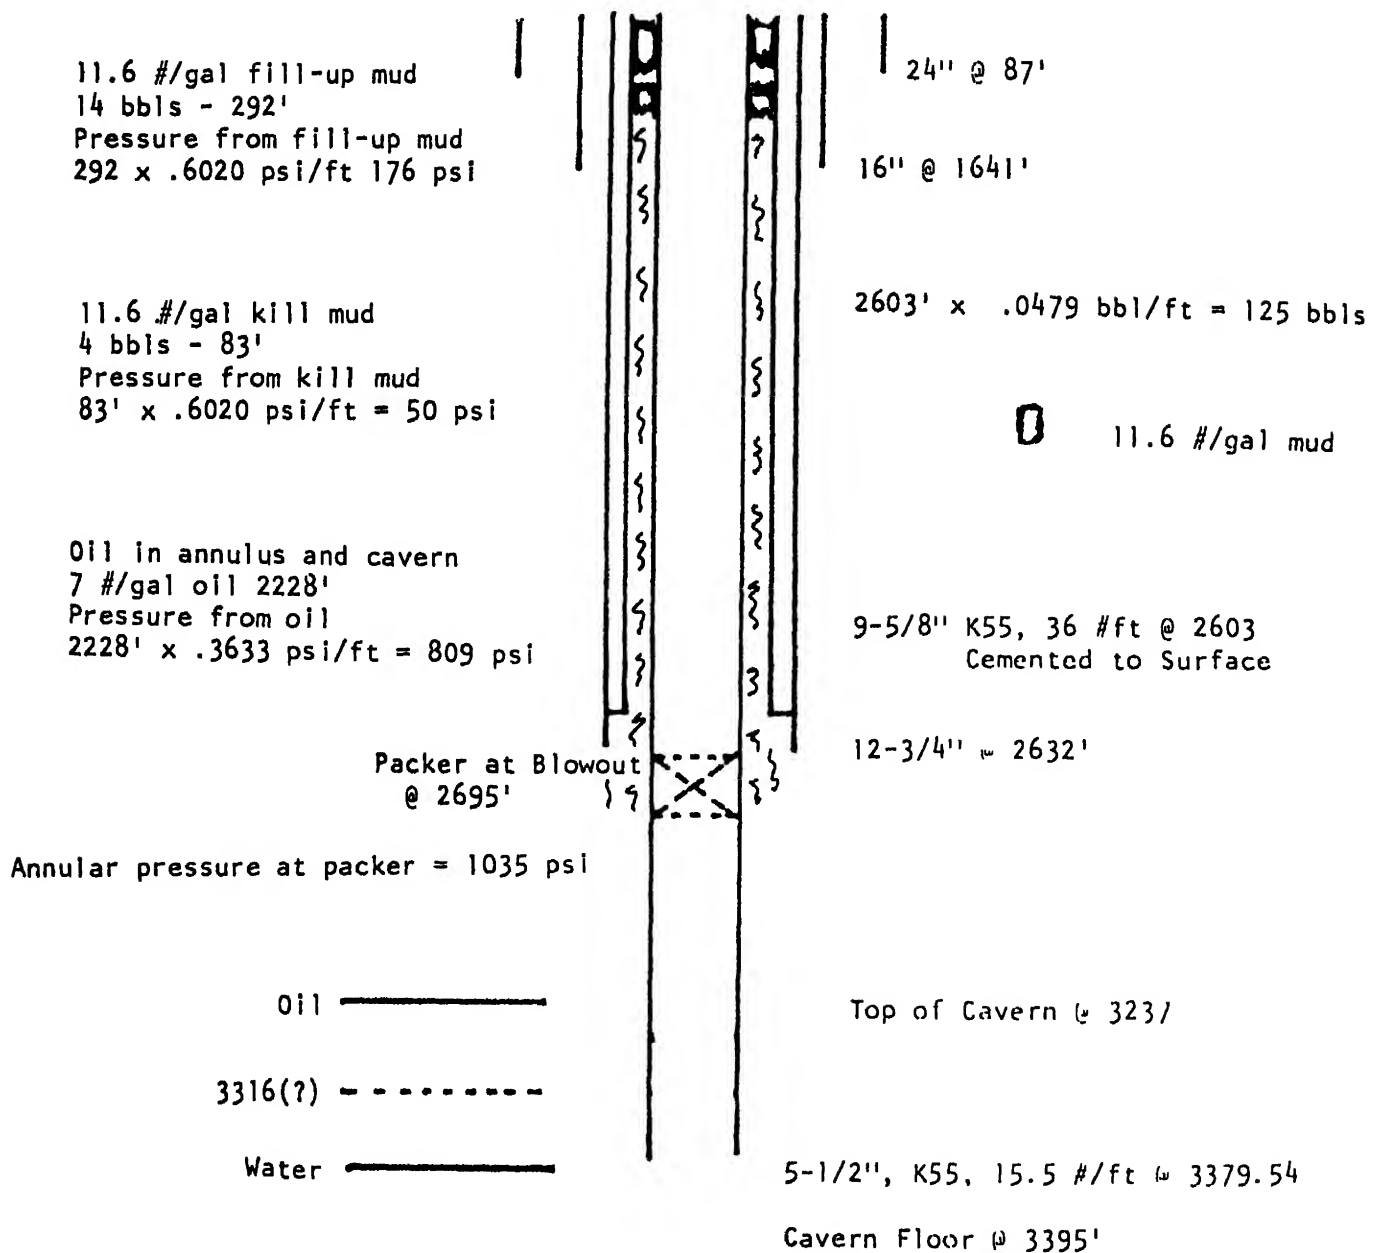
Figure 2-D

After pulling 14 joints of 5-1/2" tubing, the pressure in the annulus opposite the packer (corrected for depth, and annulus fill-up with 14 bbls of 11.6 #/gal mud) would have been 1035 psi (Figure 13) (Figure 2-D).

11.6 #/gal mud	292' x .6020	= 176 psi
11.6 #/gal mud	83' x .6020	= 50 psi
7 #/gal oil (2603 - 292' - 83') x .3633		= <u>809</u> psi
		1035 psi

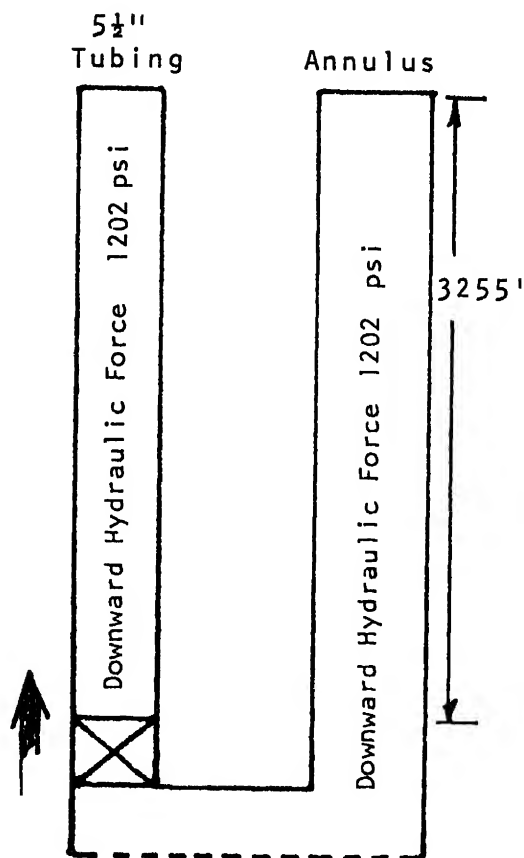
Figure 12

Well as a "U" Tube
INITIAL HYDRAULIC FORCES ON THE PACKER

Forces Balanced
on Packer

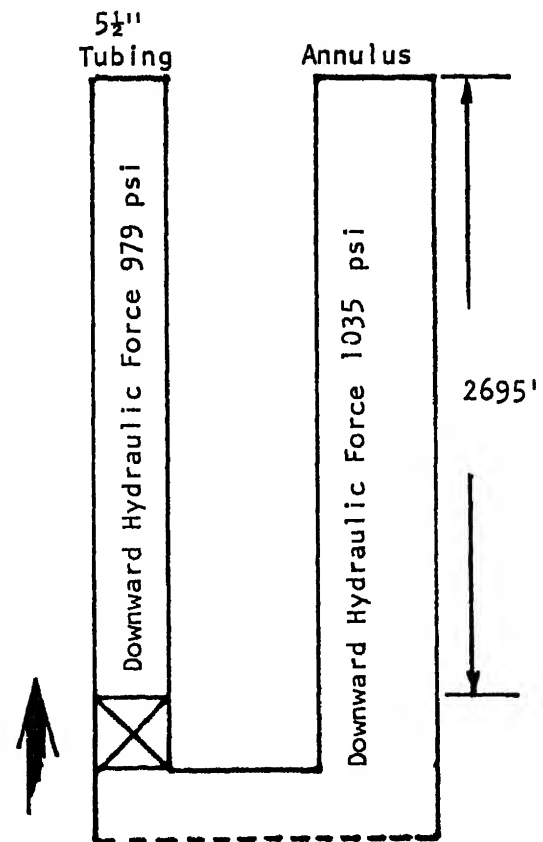
Figure 13

Well as a "U" Tube
 HYDRAULIC FORCES AT THE DEPTH
 THAT THE PACKER FAILED

Net Upward Force on
 Packer 56 psi
 or for a 5" I.D. Tubing
 1099 Pounds
 or
 1/2 Ton

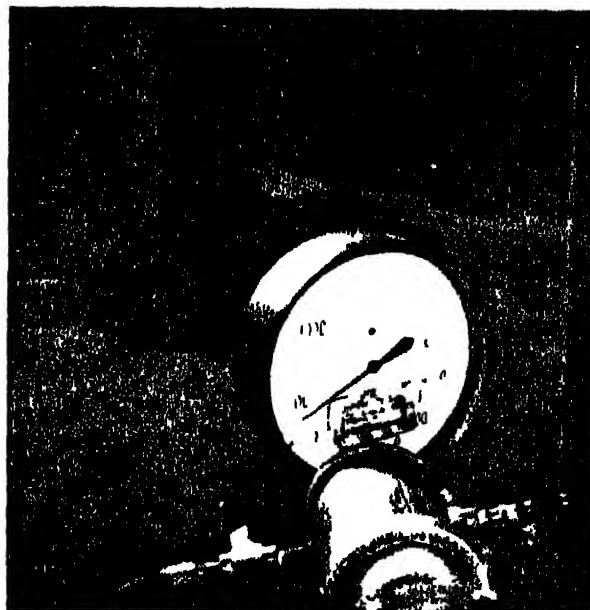
TEST w/OIL
PACKER SLIPPED @ 550 PSI
THEN HELD @ 650+ PSI
MOVED AT 700 PSI

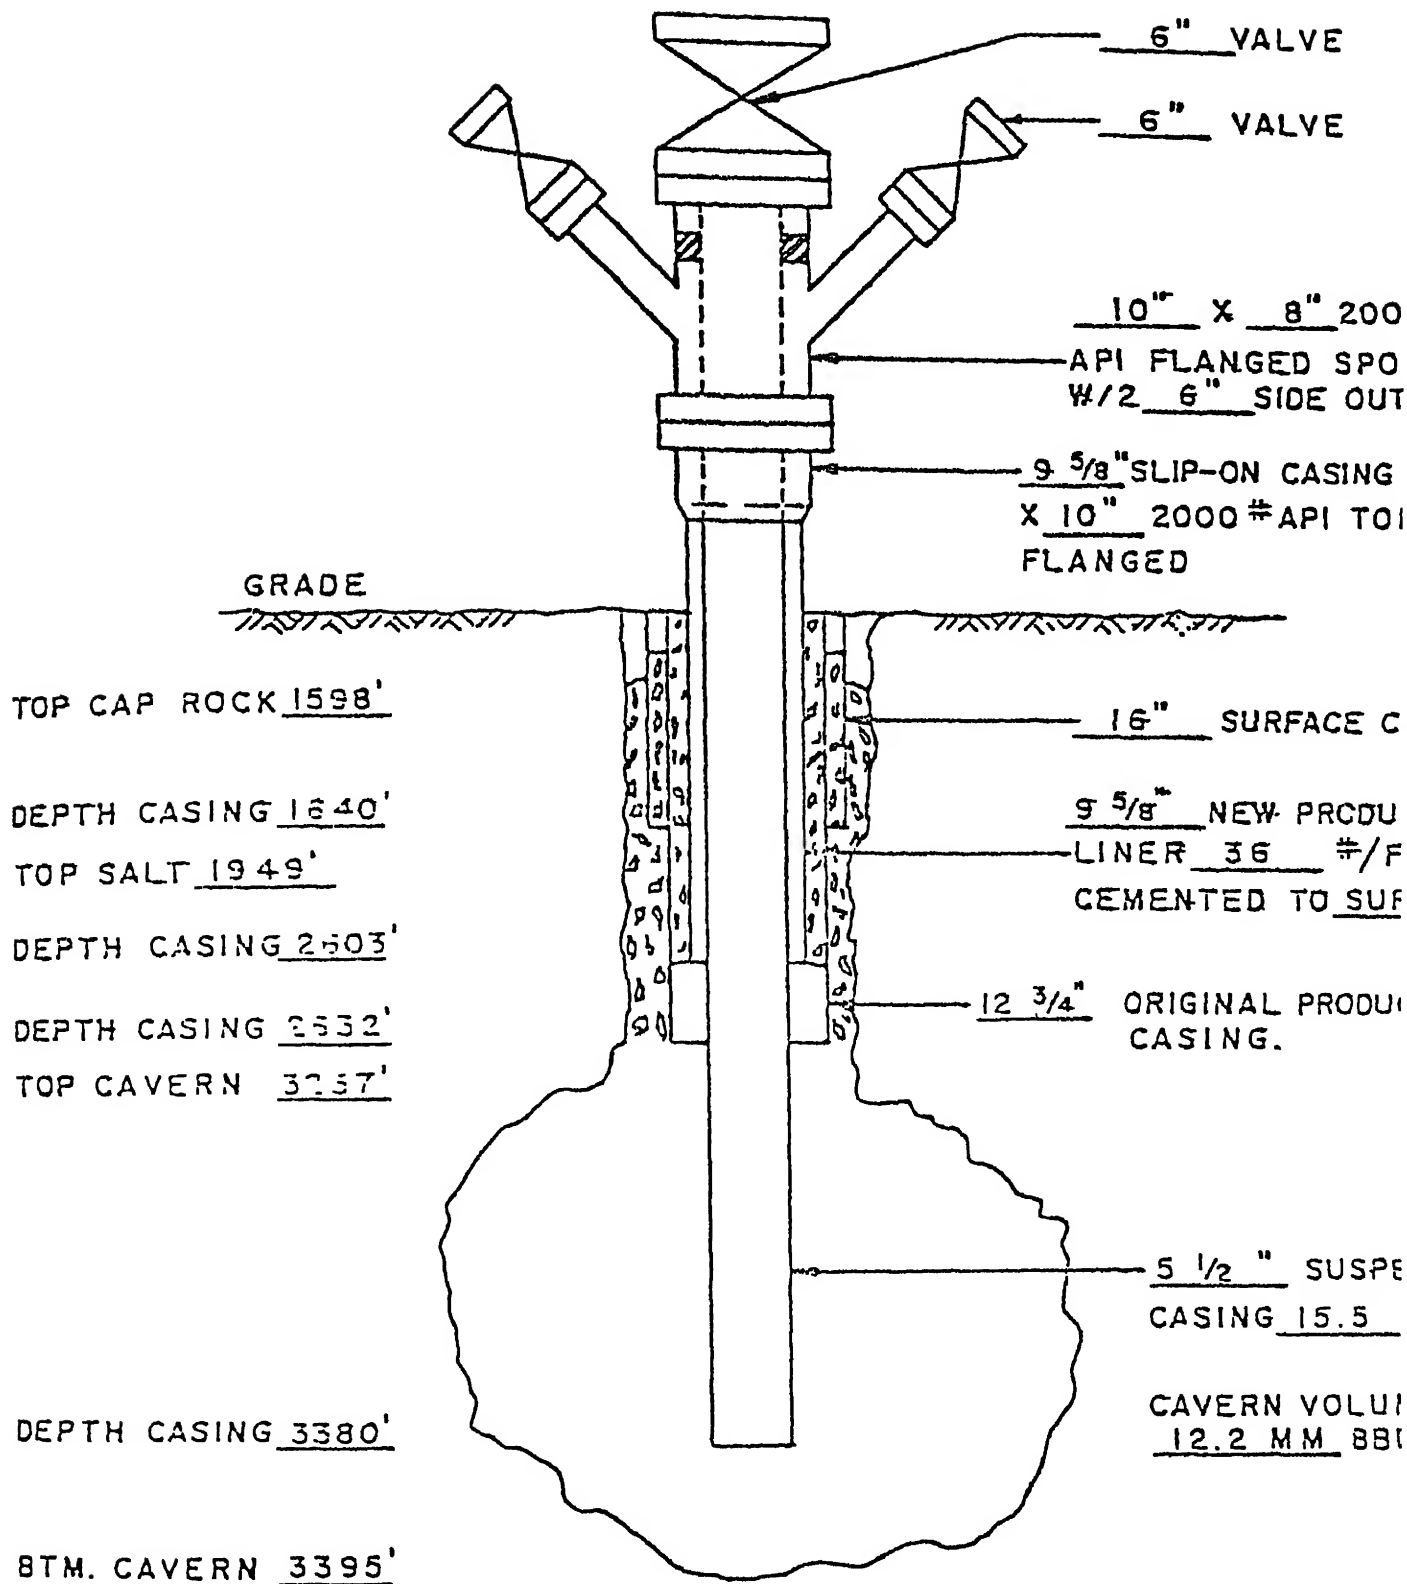
AS-BUILT
STORAGE WELL

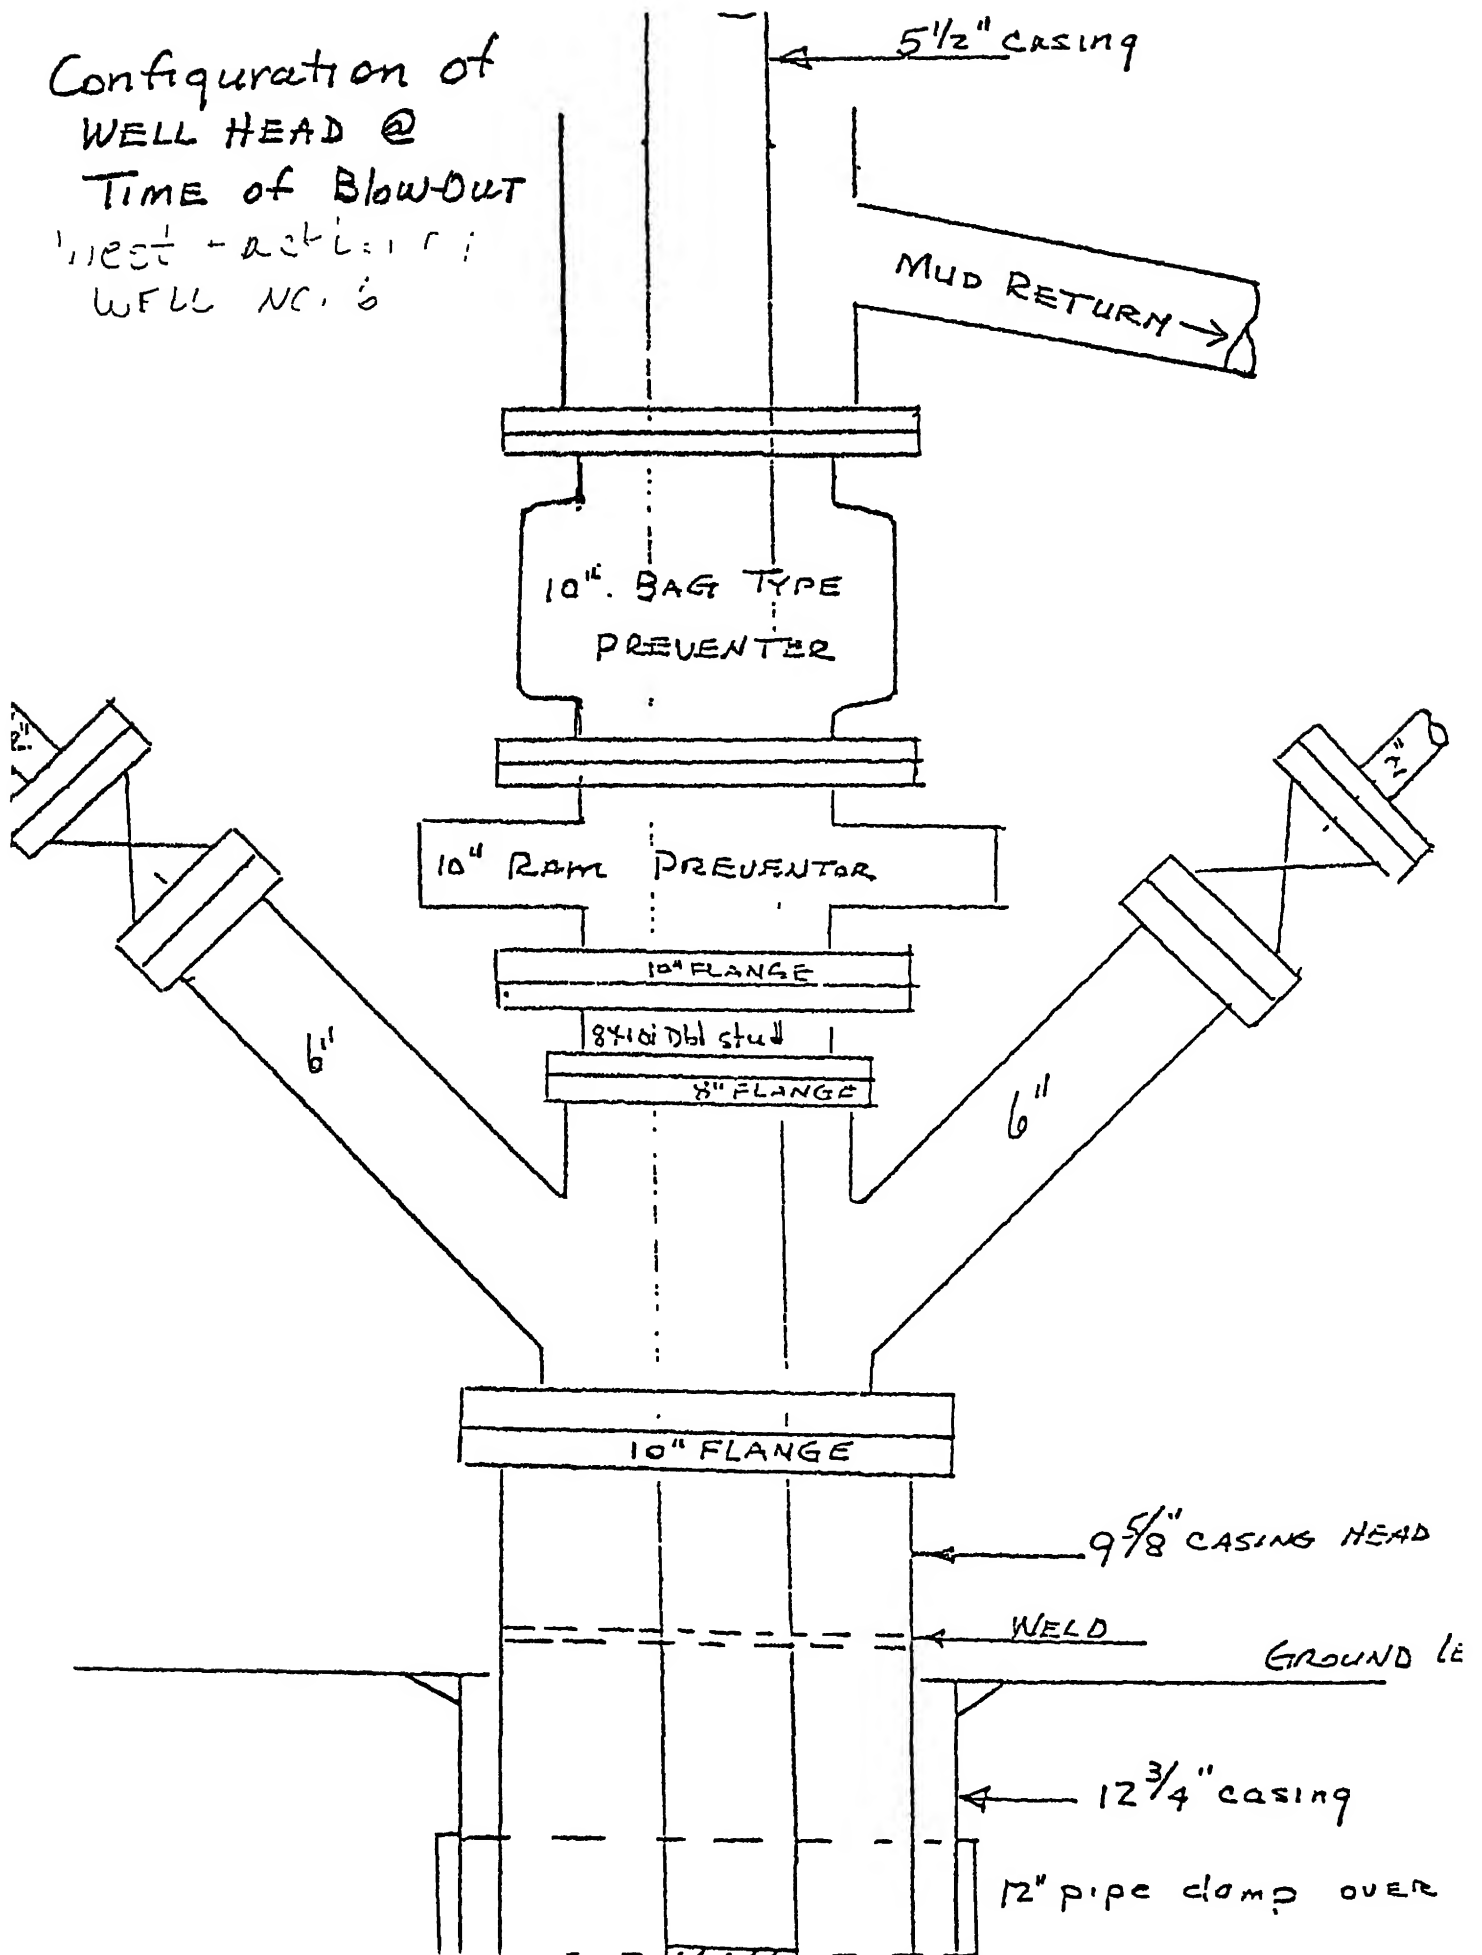
COMPLETED WELL No 6 WEST HACKBERRY
